## MEMORANDUM

**DATE:** March 27, 2023

**SUBJECT:** Cal OES Mission Task No. 2023-SOC-97887 - March 2023 Storms - Engineering  
Geologic Reconnaissance of Landslides at Wofford Heights, Kern County, CA

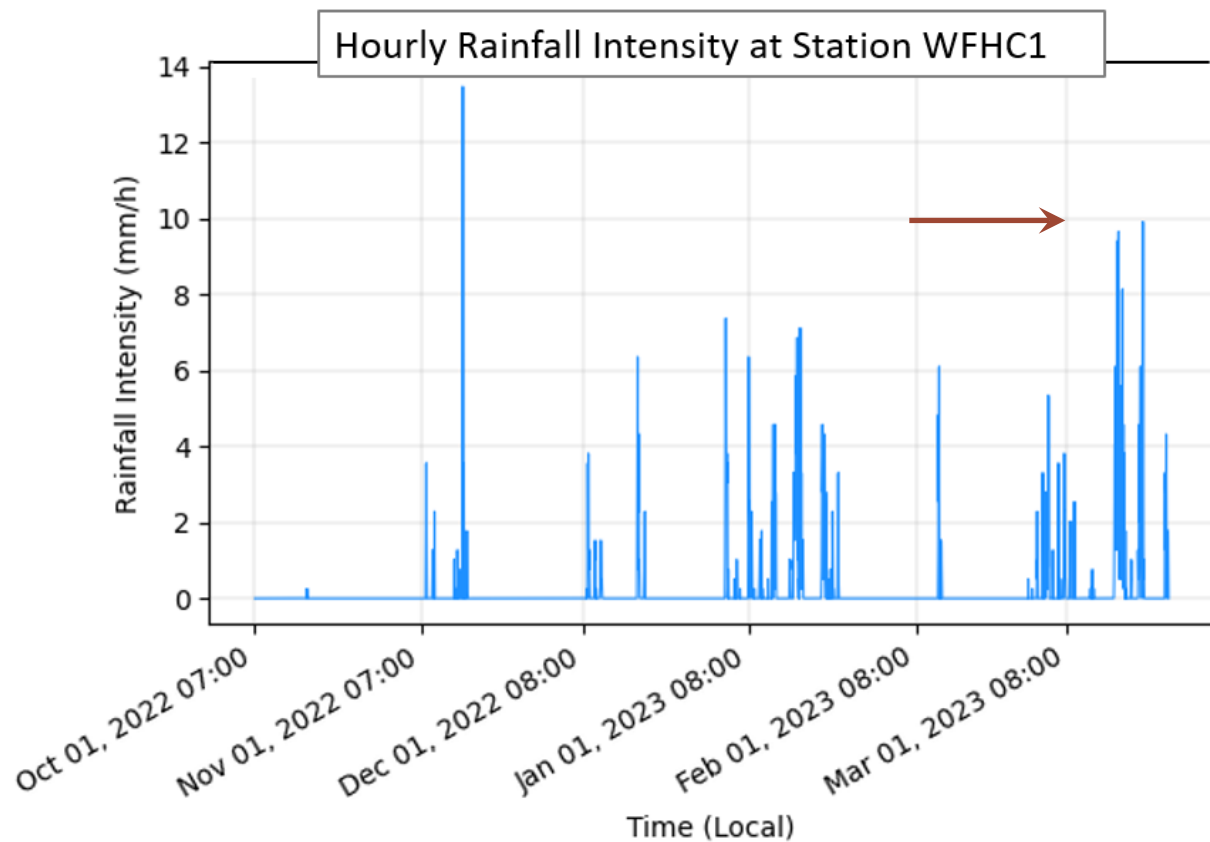
Figure 2: Rainfall intensity plot at 60-minute duration recorded at WFHC1 rain gage for period of October 1, 2022, through March 19, 2023 (see Figure 1 for gage location). Data extracted and processed by Francis Rengers (USGS). Note peak intensity of about 10 mm (0.39 inch)/hour for March 10-11. Total rainfall from October 1, 2022, through March 19, 2023, is 31.5 inches.

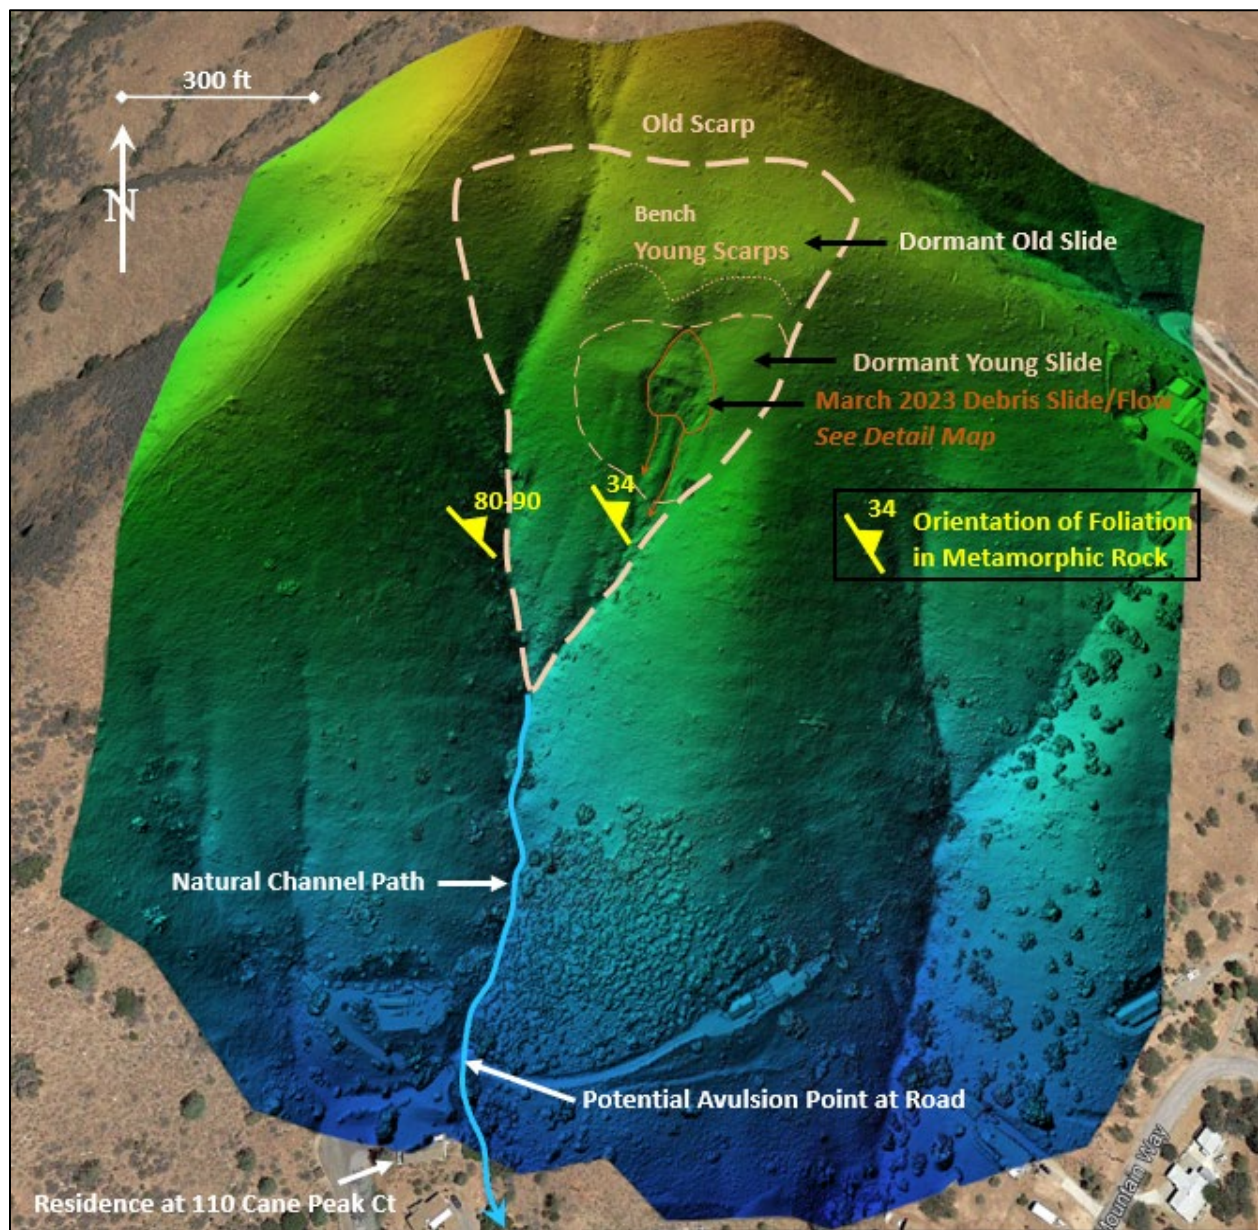
1996) a large dormant old rockslide (Qols) and a nested, younger, dormant young debris slide (Qyls) underlie the smaller landslide (debris slide and debris flows) that occurred in March 2023 (see slide annotations on Figure 4 and Photo A). Movement associated with the older slides has likely reduced the strength of the material, making slopes within the larger slides more susceptible to additional landslide movement. The landslide at Sierra Vista Drive consists of soil and colluvium weathered from the underlying Fairview Formation. Additional details regarding each subject landslide are provided below.

Figure 4: Overview map showing oblique perspective for March 2023 Cane Peak landslide nested within larger, older dormant old (Qols) and dormant young (Qyls) landslides; See Figure 5 for details of March 2023, landslide. Base map is comprised of a colored lidar hillshade topographic model provided by UC San Diego on March 16, 2023, draped onto Google Earth imagery.

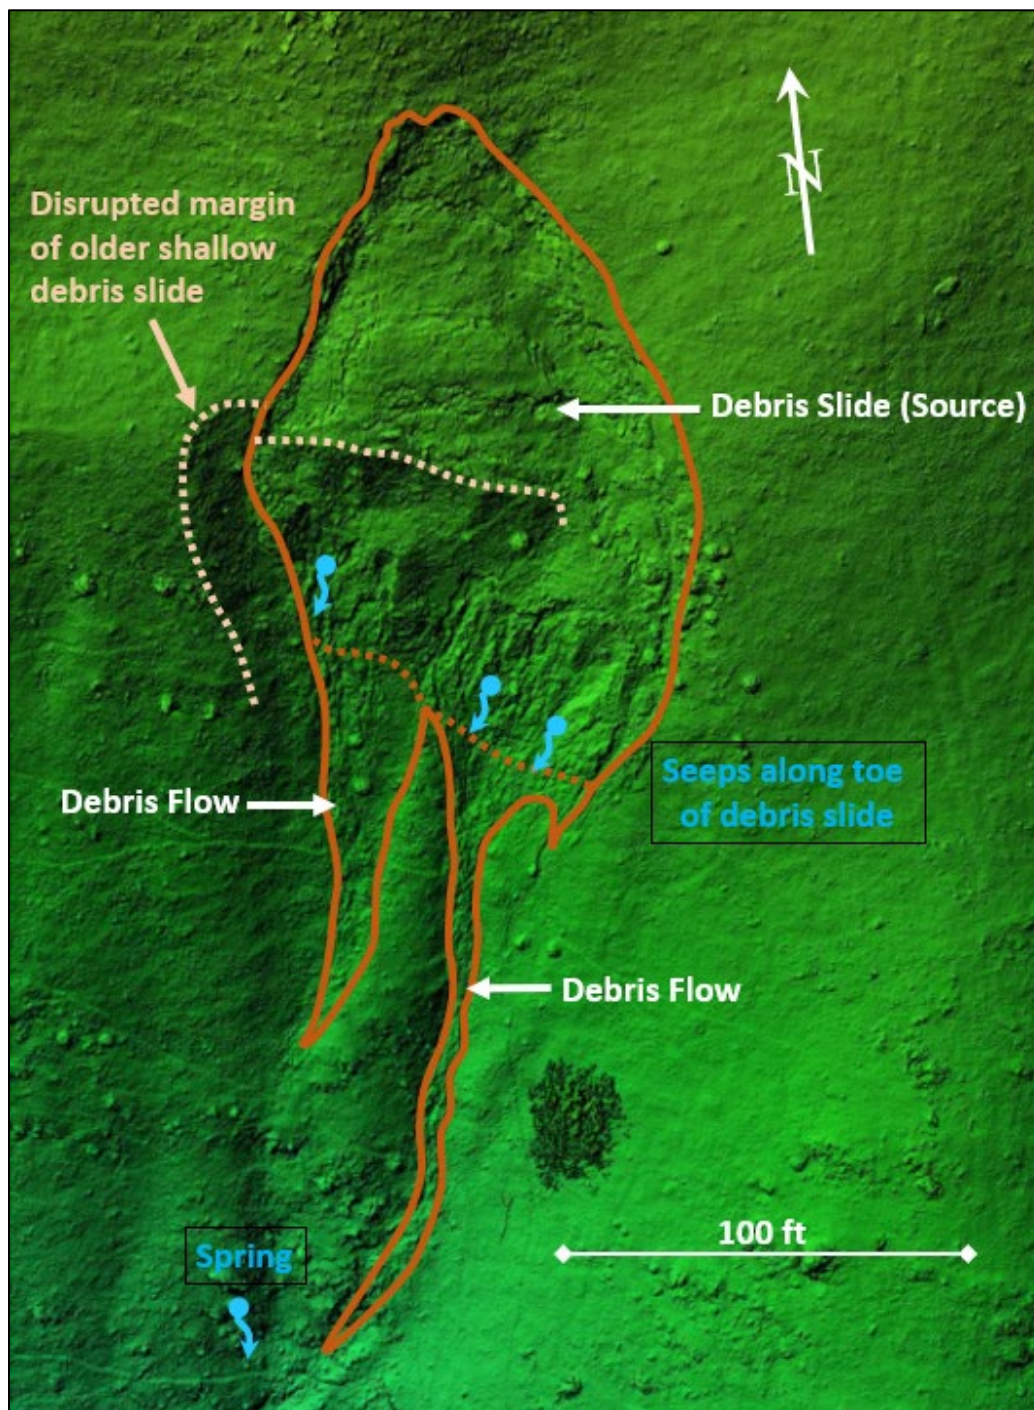
Figure 5: Detail map showing conditions at the March 2023, Cane Peak landslide. Base map is comprised of a colored lidar hillshade topographic model provided by UC San Diego on March 16, 2023, draped onto Google Earth imagery; note that image is rotated slightly relative to Figure 4.

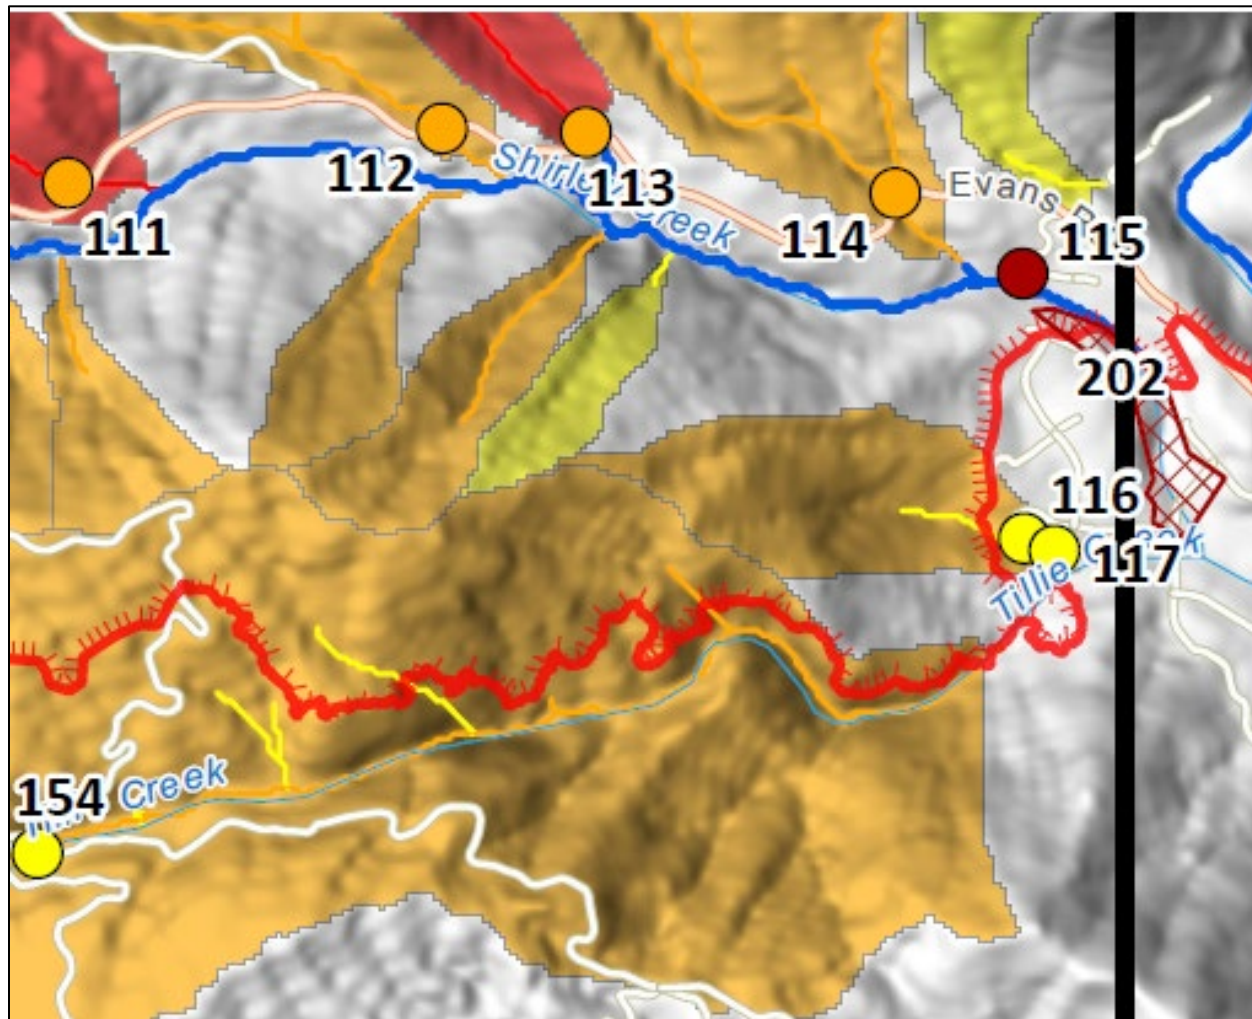
***Pala Ranches:*** No evidence of landslides or post-fire debris flows was observed. However, future storms with higher intensity rainfall could still produce debris flows in susceptible areas, as identified in the Watershed Emergency Response Team (WERT) report addressing post-fire hazards from the 2021 French Fire CALFIRE and CGS (2021). See Figure 6 for map of USGS debris flow hazard modeling and Values-at-Risk identified by the WERT in the Pala Ranches area.

Figure 6: Clip of USGS debris flow hazard map for the French Fire showing source areas burned upstream of the Pala Ranches area. Note that the WERT identified two low hazard Values-at-Risk (VARs) in this area at VARs 116 and 117. No evidence of debris flows or hyper-concentrated flows were observed in this area as of March 16. Note that drainages are color coded based on the combined probability of a debris flow and estimated debris flow volume for a design 15-minute storm intensity of 1.1 inch/hour (28 mm/hour), which equates to 0.28 inches (7 mm) of rain in 15 minutes. The peak rainfall recorded at the WFHC1 gage was 0.39 inch/hour; note that 15-minute duration intensity was not recorded at this gage.

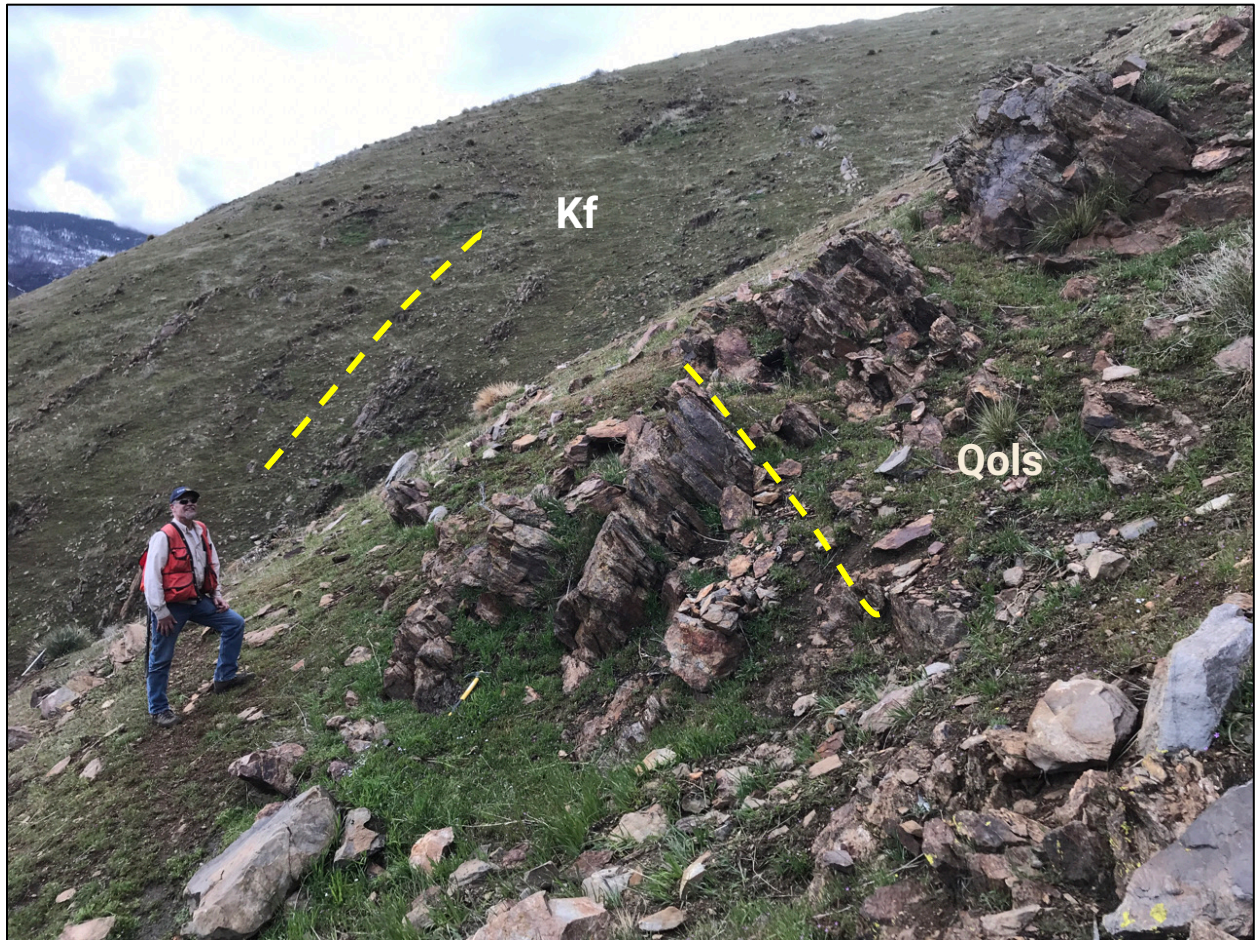
Photo A: View northwest of quartzite and schist outcrops of the Fairview metasedimentary formation (Kf) exposed downslope of March 2023 Cane Peak landslide. Note that the metamorphic foliation in exposures on the ridge in the background have a near-vertical inclination whereas the foliation in the foreground has a relatively oblique trend (as highlighted in yellow) and dips moderately to the north (see foliation orientations mapped in Figure 4). The discrepancy in orientations suggests the outcrops in the foreground may have been rotated by ancient slide movement (Qols).

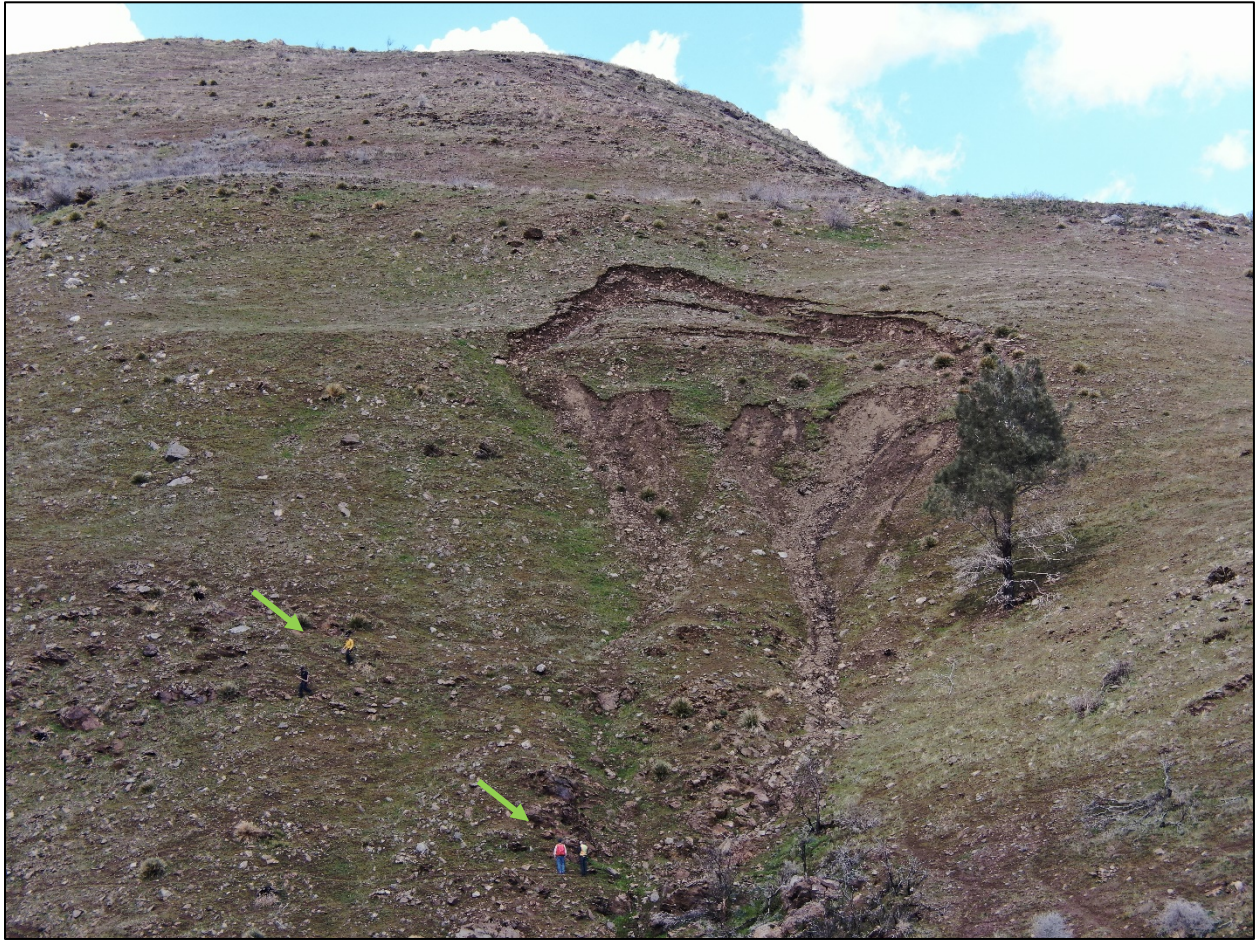
Photo B: View north of Cane Peak landslide; note CGS and Kern County staff for scale (denoted with green arrows). Note benches at and above head of March landslide, which likely formed due to past movement of older, larger landslides. Also note debris flow tracks down slope originating from main debris slide mass. Drone photo provided by UC San Diego.

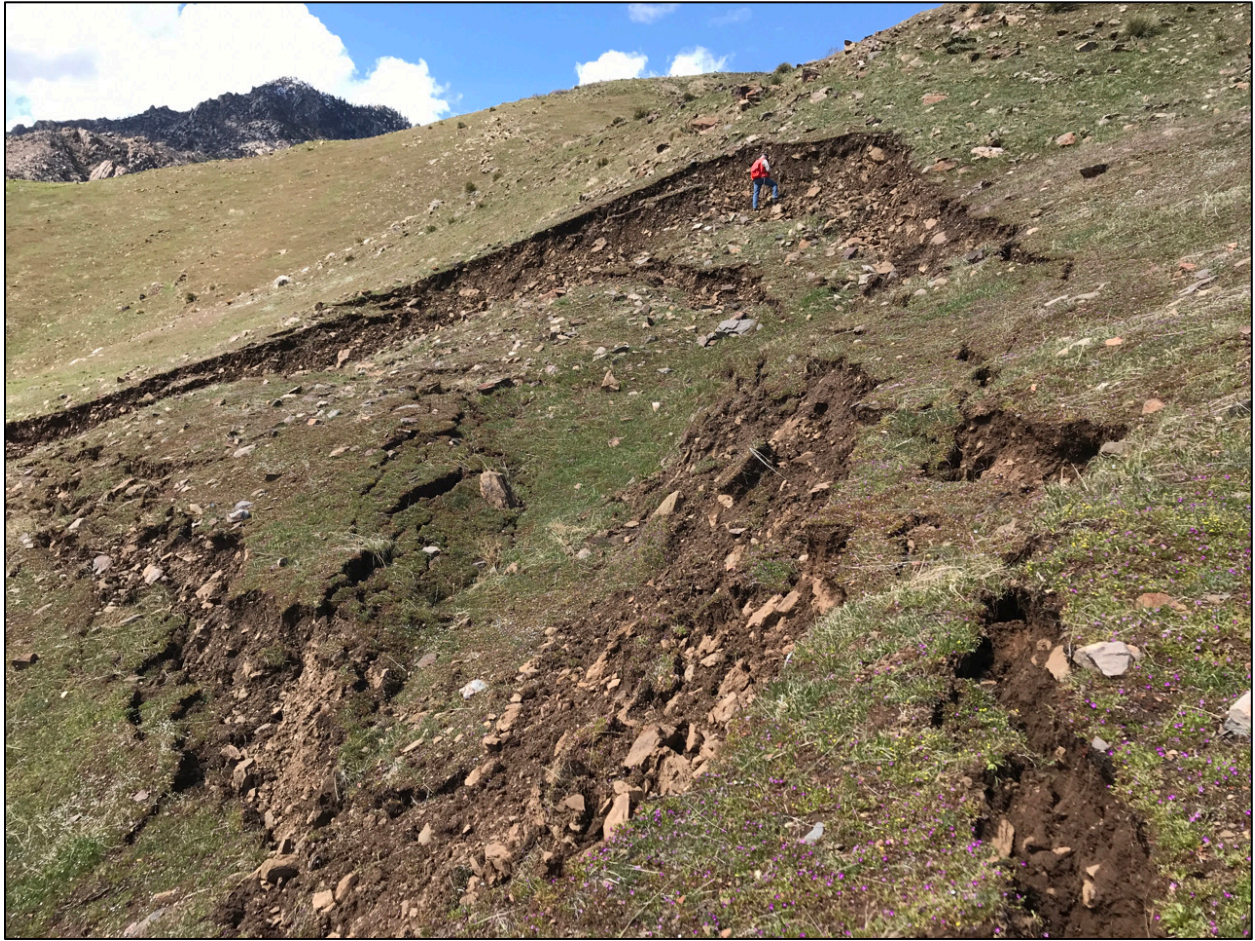
Photo C: View northwest along main scarp and internal secondary scarps of the Cane Peak landslide.

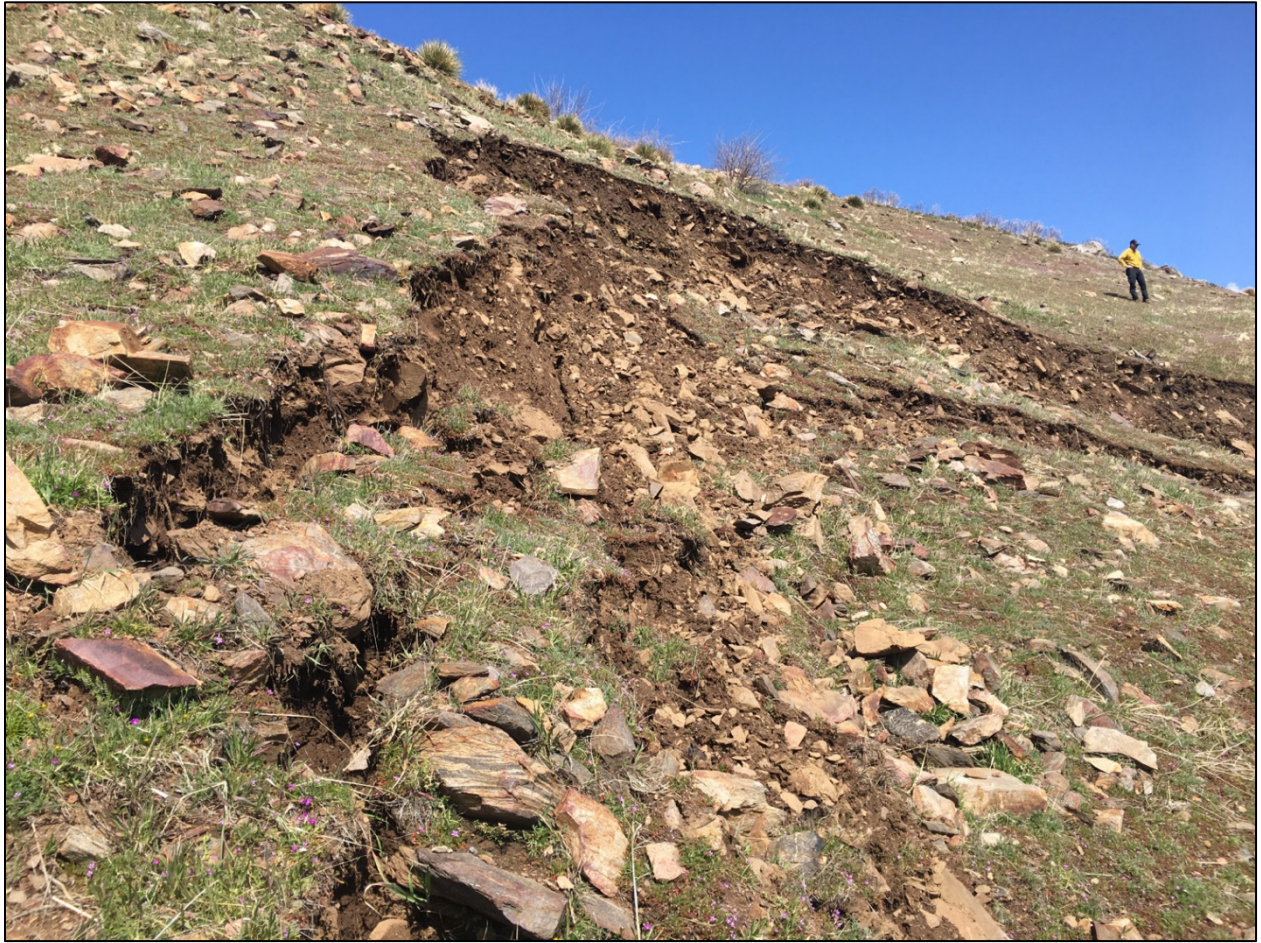
Photo D: View northeast of main head scarp showing disrupted fragments of Fairview metasedimentary rocks; scarp is five feet high. Note person in upper right background for scale.

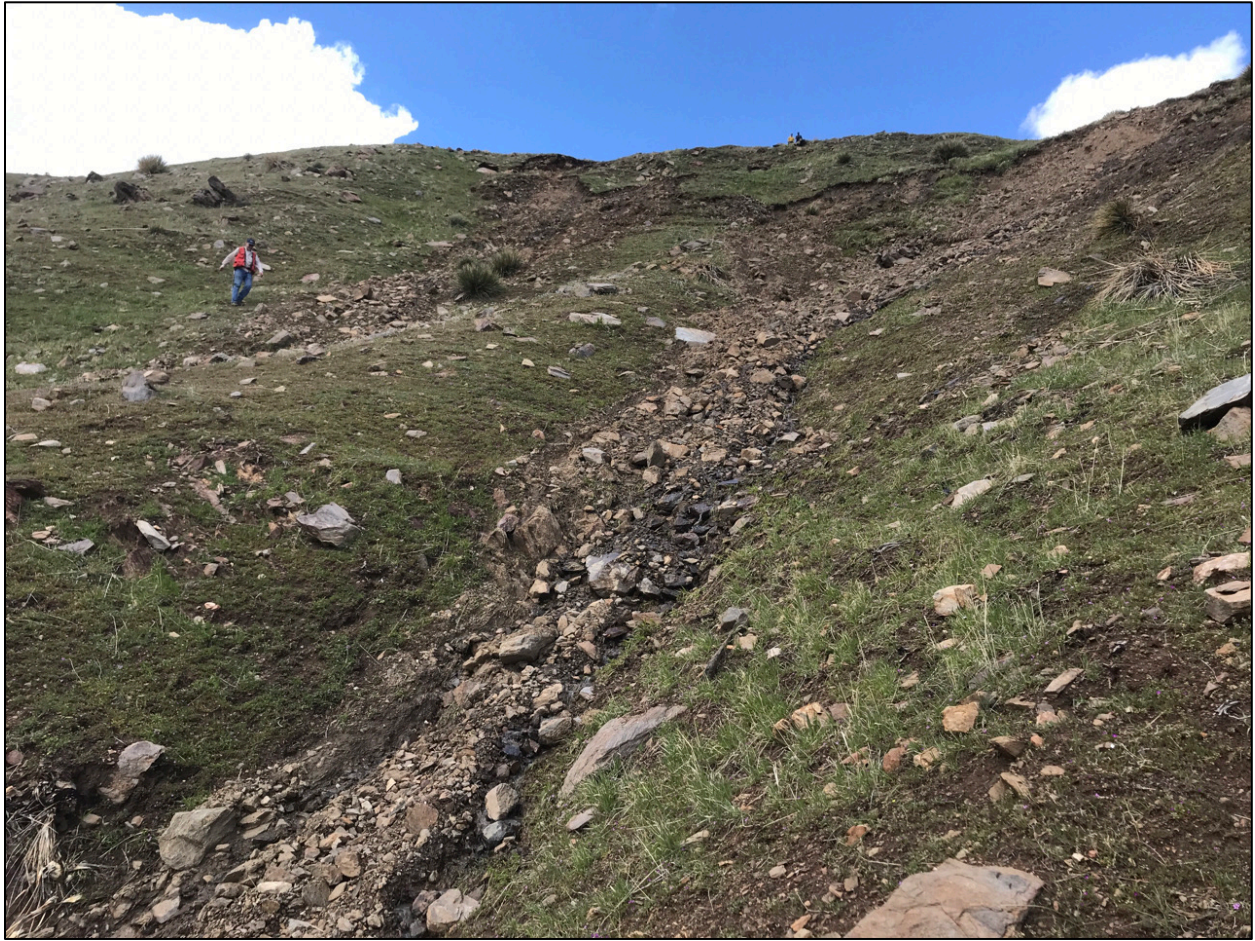
**Cane Peak Landslide:** The CGS team met with Matt Henry and Andrew Duitsman from the Kern County Fire Department (KCFD) at Cane Peak Court. CGS also spoke with Eric Lo and other members of a team from UC San Diego who were in the process of flying lidar and photographic imagery of the landslide area with a drone (see Photo B). CGS staff then hiked up the slope to the location of the March landslide and documented the geologic and geomorphic conditions (see Figure 5). The landslide initiated as a debris slide (definition at: <https://www.conservation.ca.gov/cgs/landslides#debrisslides>) with a maximum width of about 110 feet and a downslope length of about 130 feet. A five-foot-high scarp is present at the head of the slide, which exposes older disrupted landslide debris (see Photos C and D). The lower face of the debris slide displaced the scarp of a previous, possibly historic, shallow debris slide. Ground water was observed actively seeping from the face of the slide (see Figure 5). In addition, debris flows originated from the lower face of the debris slide mass and flowed down two parallel channels for distances of about 100 and 135 feet, respectively, with gradients of about 30 degrees (see Photo E).

Photo E: Debris flow deposits down gradient from main landslide mass. Note debris flow in foreground originating from main debris slide mass; note active water flow from seepage at source in debris slide face. The channel gradient is approximately 30 degrees.

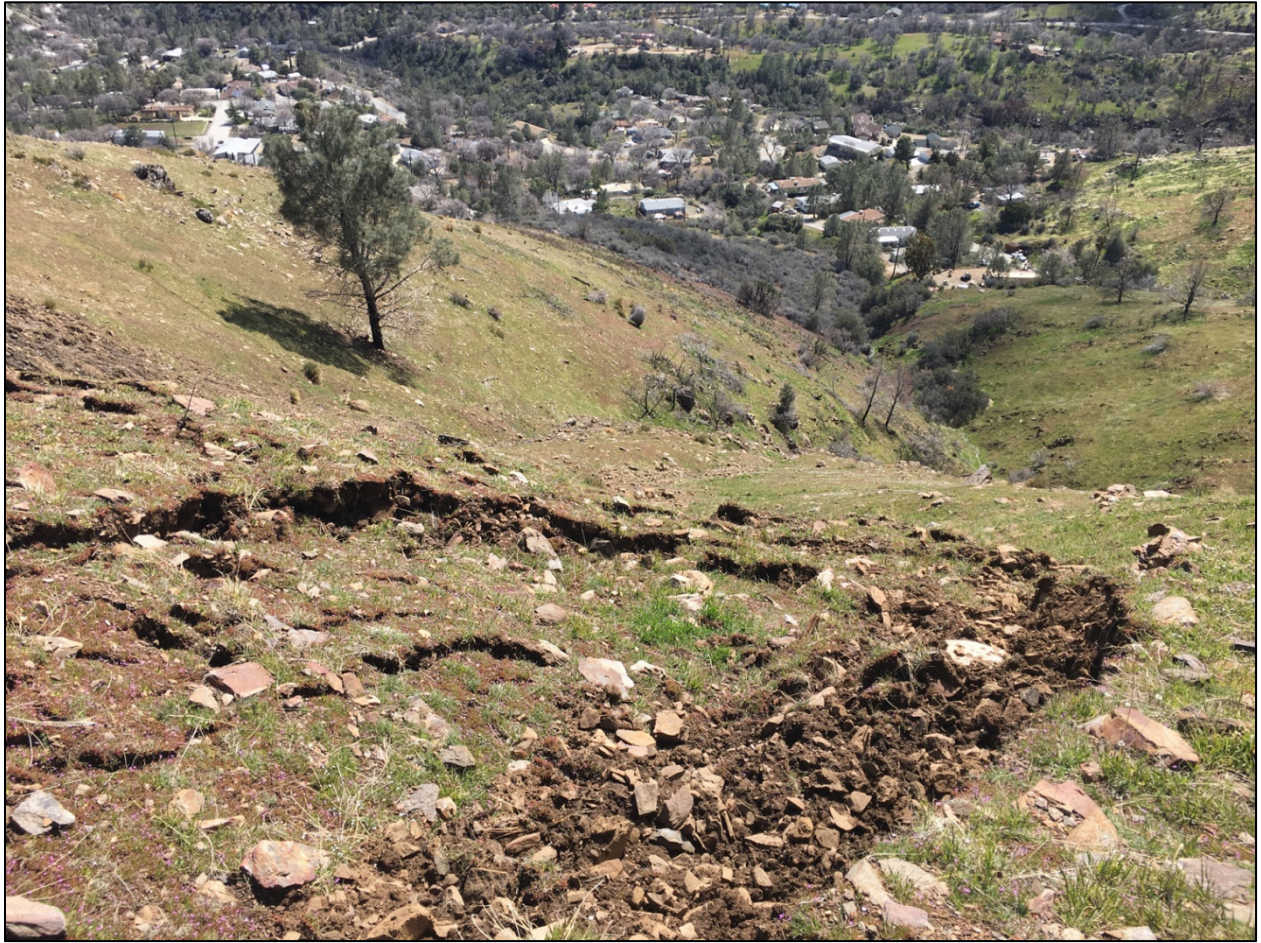
Photo F: View down slope from west margin of slide mass toward developed area in vicinity of Cane Peak Court.

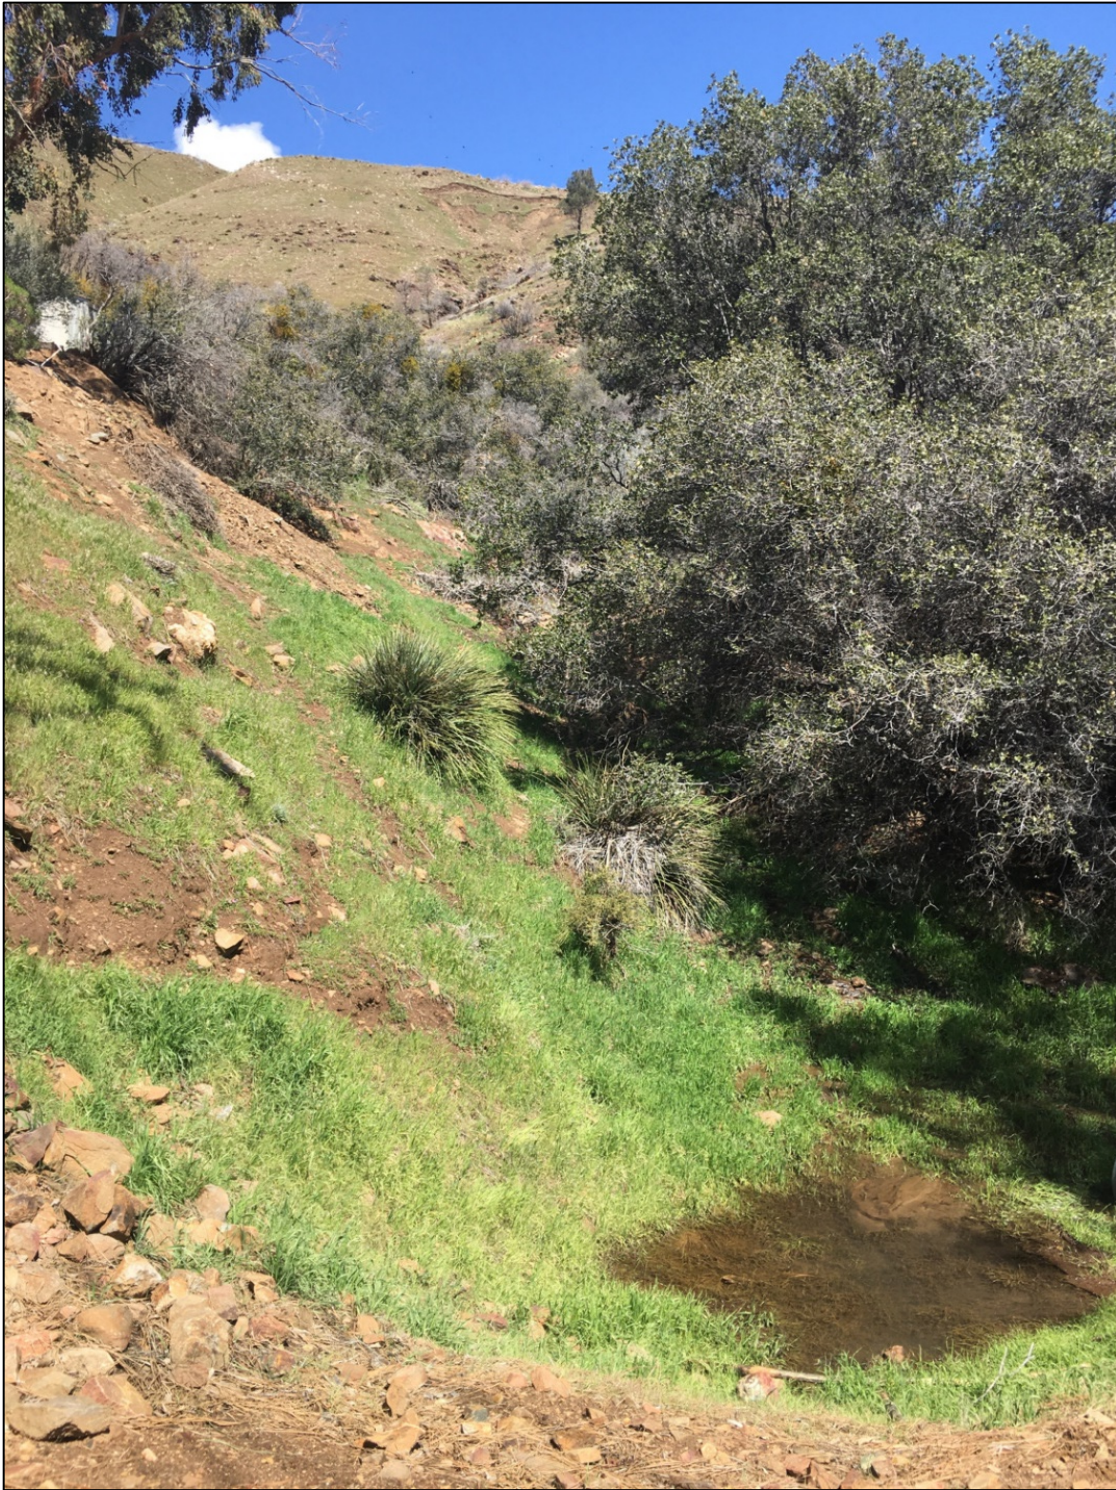
Photo G: View north up slope from Cane Peak Court toward landslide; note small catchment area in foreground.

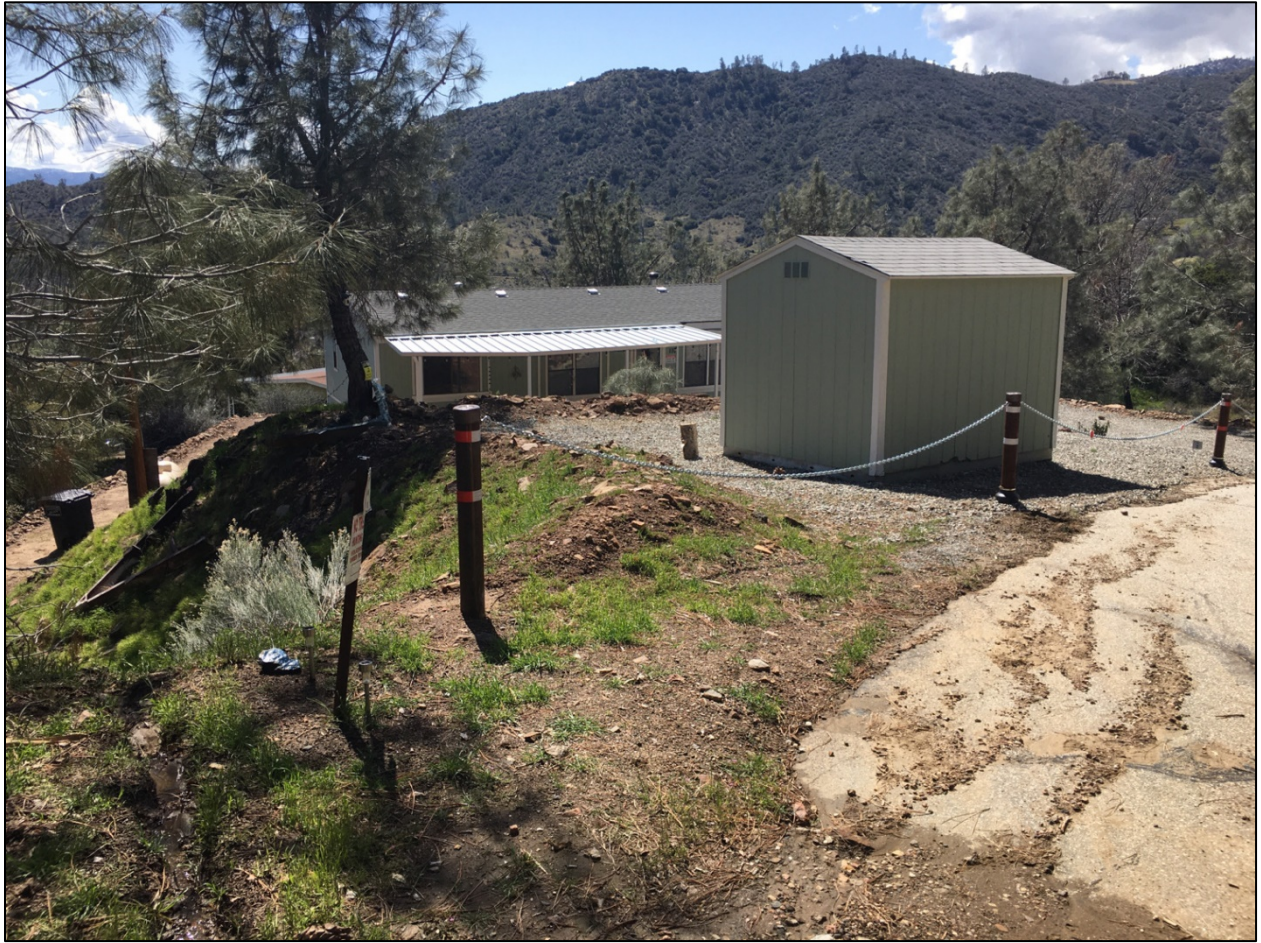
Photo H: Residence at 110 Cane Peak Court on opposite side of road from channel that drains from landslide area.

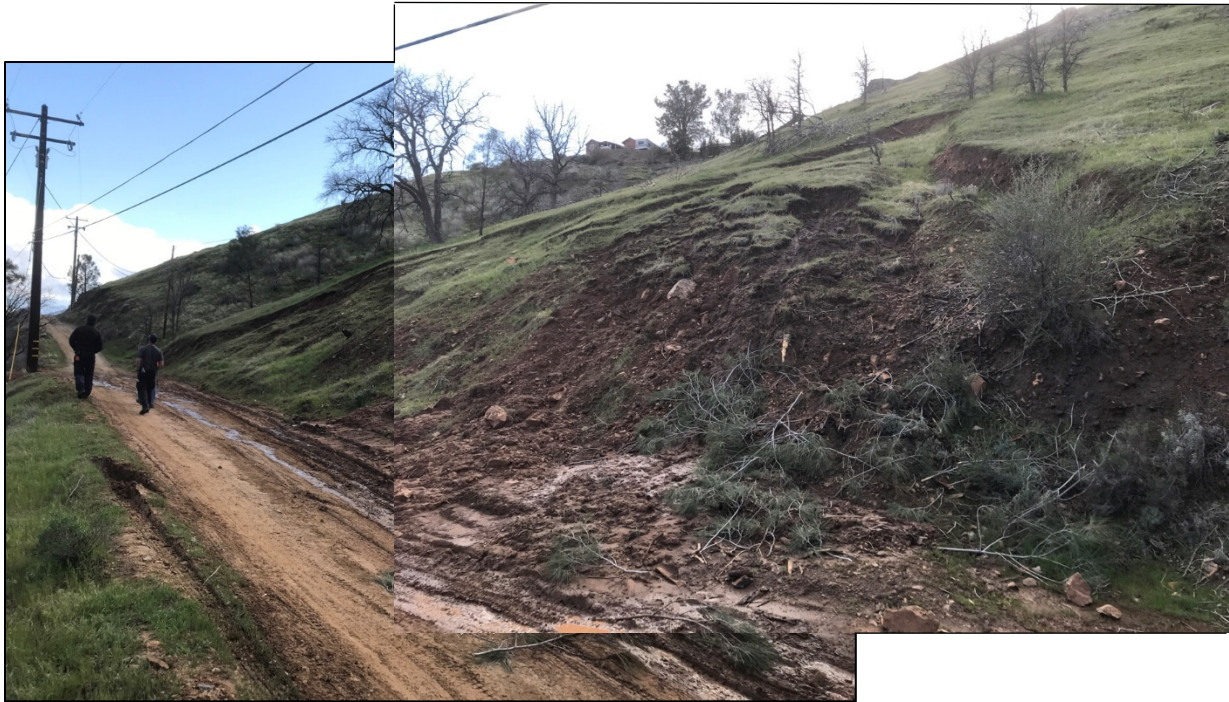
**Sierra Vista Drive Landslide:** The landslide along Sierra Vista Drive occurred in an old ascending cut slope on the west side of the road (Photo I). Residents have reported that slope failures have occurred here at times over at least the past 15 years. The landslide is composed of soil and colluvium (slope deposits) derived from weathering of the underlying metamorphic bedrock and the type classifies as an earth slide/flow (see definition at: <https://www.conservation.ca.gov/cgs/landslides#earthflows>). The landslide is about 50 feet wide, and the scarp of the slide varies in elevation from 15 to 25 feet above the road grade. The March landslide moved up to six feet laterally into the road alignment based on a resident's report, but no evidence of slide movement was observed on the downslope side of the road.

Photo I: Landslide (earth slide/flow) sourced from soil and colluvium exposed in old cut slope along Sierra Vista Drive.

***Sierra Vista Drive Landslide:*** The Sierra Vista landslide area was restricted to the road area, and additional movement appears likely to be localized to the area upslope and on the uphill side of the road prism. The slide is not expected to catastrophically affect residences downslope of the road. Potential emergency mitigation includes continued maintenance of the road to clear debris as needed following future storm events to provide access for the residents. A permanent solution to mitigate future slope failures would be construction of a retaining structure. It should be noted that removal of the slide debris with no other mitigation may create more slope instability.
