## MEMORANDUM

**DATE:** March 27, 2023

**SUBJECT:** Cal OES Mission Task No. 2023-SOC-97887 - March 2023 Storms - Engineering  
Geologic Reconnaissance of Landslides at Wofford Heights, Kern County, CA

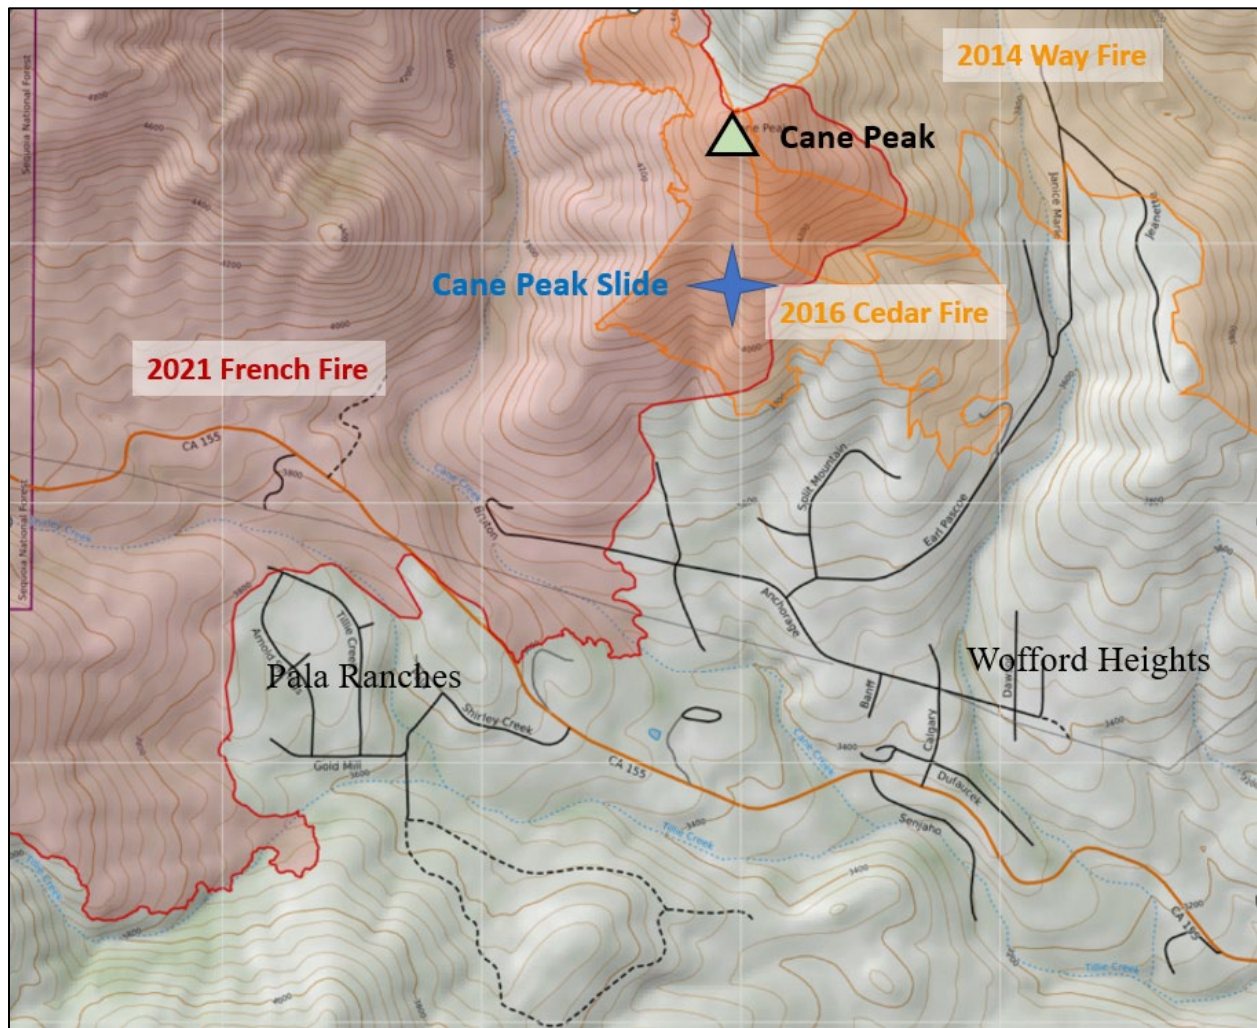
Areas northwest of Wofford Heights have been burned by three wildfires since 2014 (see Figure 3). The Cane Peak landslide is located just inside of the perimeters of both the 2016 Cedar Fire and the 2021 French Fire, and is just southwest of the perimeter of the 2014 Way Fire. Review of post-fire hazard assessments for the Way Fire (CGS, 2014) and French Fire (CALFIRE and CGS, 2021) and pre-fire Google Earth imagery indicates that the vegetation at the location of the Cane Peak landslide was a patchy mix of small shrubs and grasses, which burned at low soil burn severity (SBS map in CALFIRE and CGS, 2021). Compared with adjacent areas outside the fire perimeters, the vegetation currently appears to be in the process of returning to pre-wildfire conditions, with abundant grasses and shrubs being reestablished and generally smaller than those on nearby hillslopes outside of the listed historic fire perimeters. No rills were observed in the Cane Peak area and the style of failure for the Cane Peak landslide indicates that it was driven by infiltration of rain water rather than by post-fire runoff, which is consistent with the relatively low, short-duration rainfall intensities recorded at the WFHC1 gage and the low combined hazard for post-fire debris flows identified by USGS debris flow modeling at the Cane Peak slide drainage (CALFIRE and CGS, 2021). The observed peak rainfall intensity of 0.39 inch/hour is approximately one-half of the fire-wide threshold of 0.78 inch/hour for triggering debris flows recommended for year-one, post-fire conditions at the French Fire. The Sierra Vista Drive landslide was not located within any known historic fire perimeter.

Figure 3: Fire History Map of Cane Peak area (obtained from CalTopo interactive website: <https://caltopo.com/map.html#ll=35.71987,-118.48835&z=16&b=mbt&a=fire>).
